INDOOR AIR QUALITY ASSESSMENT

**Center School
403 Great Road
Stow, MA 01775**

Prepared by:
Massachusetts Department of Public Health
Center for Environmental Health
Emergency Response/Indoor Air Quality Program
August 2005

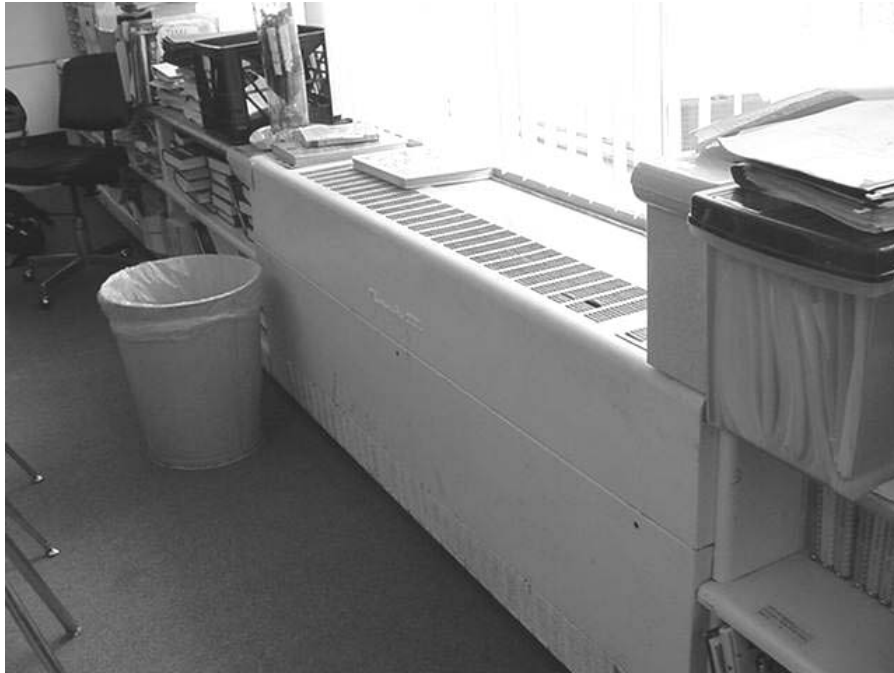
Picture 1

Fresh air in classrooms is supplied by unit ventilator (univent) systems (Picture 1). A univent is designed to draw air from outdoors through a fresh air intake located on the exterior wall of the building (Picture 2) and return air through an air intake located at the base of the unit ([Figure 1](#)). Fresh and return air are mixed, filtered, heated and provided to classrooms through an air diffuser located in the top of the unit. Many univents were operating weakly or found to be off at the time of assessment. Obstructions to airflow, such as papers and books stored on univents and bookcases and carts and desks located in front of univent returns, were seen in a few classrooms (Picture 3). In order for univents to provide fresh air as designed, units must be allowed to operate and remain free of

Classroom univent

1. Operate both supply and exhaust ventilation continuously, independent of classroom thermostat control, during periods of school occupancy to maximize air exchange.
2. Examine each univent for function to ascertain if an adequate air supply exists for each room. Check fresh air intakes for repair and increase the percentage of fresh air intake if necessary.
3. Remove all blockages from univents and exhaust vents to ensure adequate airflow. Clean univent and exhaust vents periodically to prevent excessive dust build-up.

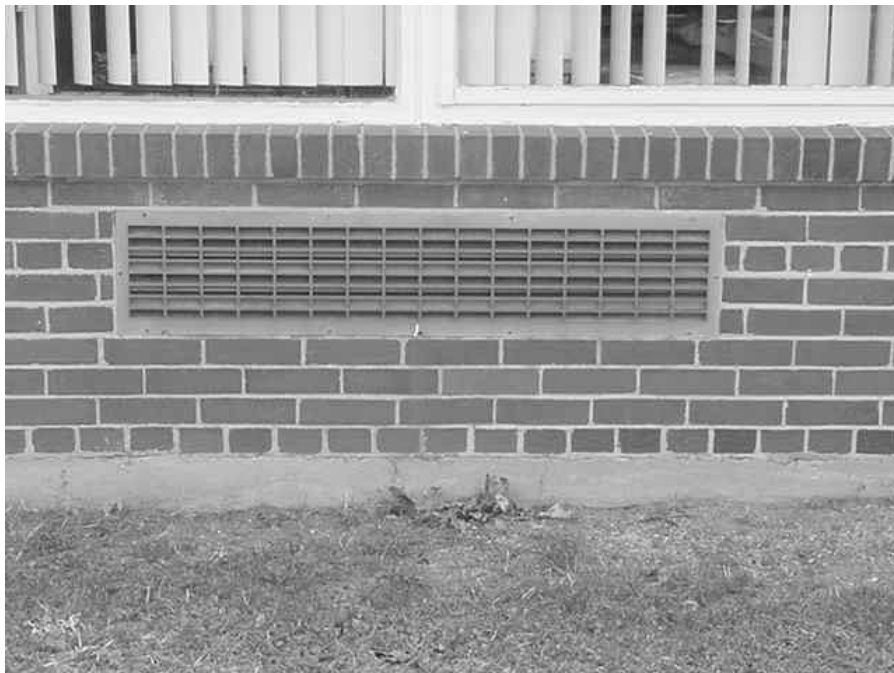
Picture 2

Univent fresh air intake

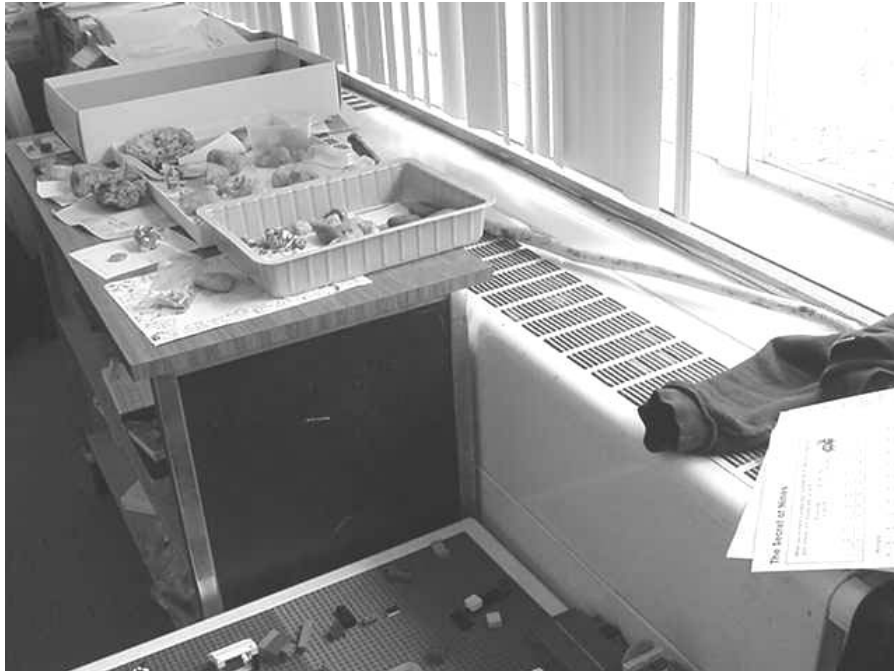
Picture 3

obstructions. Please note, univents appear to be original to the building. Therefore, repair/replacement of parts may be difficult for units of this age.

Obstructions to a univent

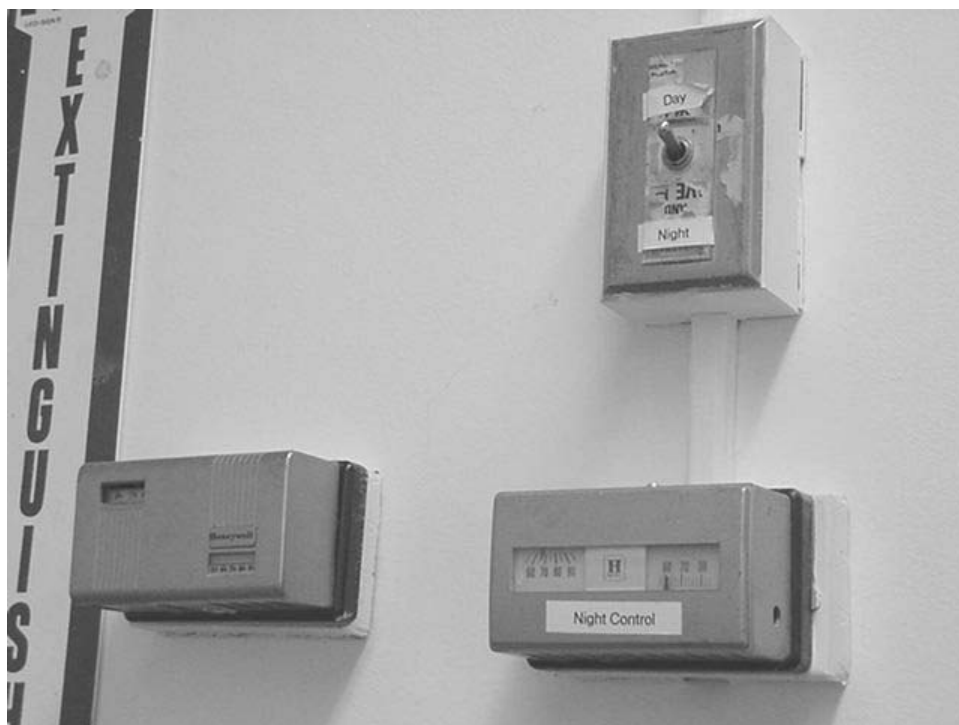
Picture 4

The univent located in the Stone Building is controlled by a thermostat with switch activated 'day' and 'night' settings (Picture 4). At the time of the assessment, the univent was in the night setting. The night setting on the thermostat activates the HVAC system at a preset temperature, approximately 60 ° F. Once the preset temperature is reached, the HVAC system is deactivated. Therefore, no mechanical ventilation is provided until the thermostat re-activates the system. The school custodian switched the univent to the day setting, essentially activating the univent. According to the school custodian, during routine univent filter changes, the filter for the Stone Building univent is not typically soiled in comparison to other CS classroom univents. This suggests that the univent is rarely switched from the night to day mode. Without operating the unit, no means for supplying fresh air to the Stone Building exists. As a result, typical classroom pollutants would tend to accumulate, leading to occupant discomfort and complaints regarding indoor air quality.

Thermostat controls to Stone Building univent

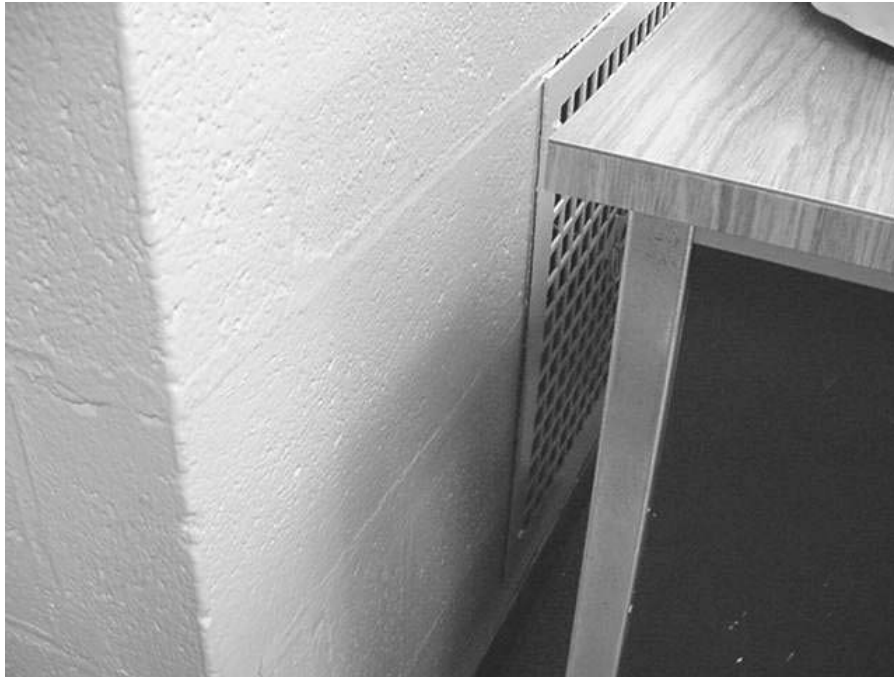
Picture 5

Exhaust ventilation in classrooms is provided by ducted, grated wall vents powered by rooftop motors. At the time of the assessment some exhaust vents were not operating. In addition, a number of wall exhaust vents were obstructed by desks, bookcases and other items (Picture 5). As with the univents, in order to function properly, exhaust vents must be activated and remain free of obstructions.

Classroom exhaust, note obstruction by table

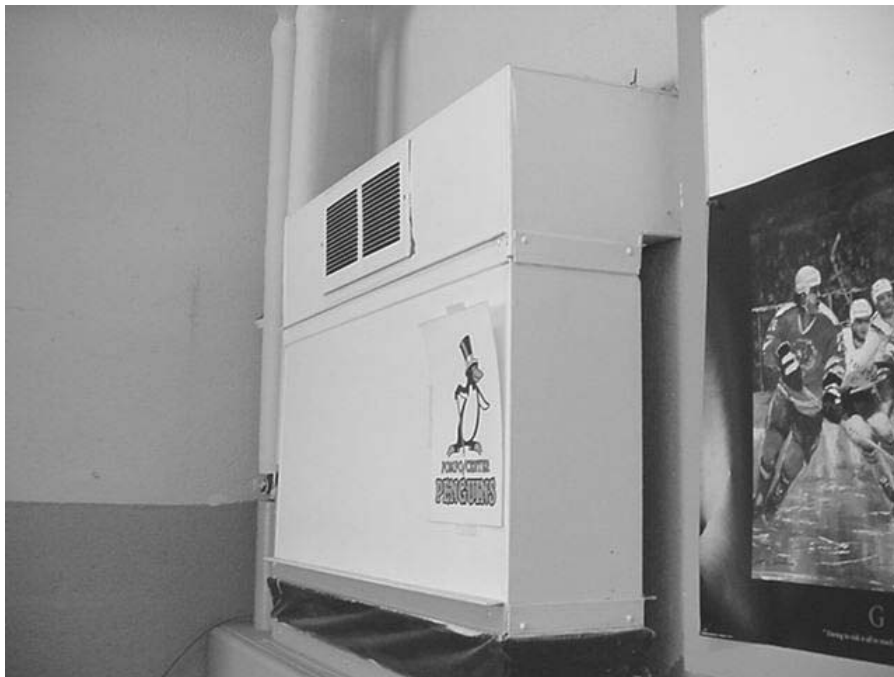
Picture 6

Like many offices/rooms, the guidance office relies on windows for fresh air. However, this room also has a fan coil unit (FCU) that provides supplemental heating to the room (Picture 6). The FCU functions in a manner similar to that of a univent, where air drawn into the FCU is filtered, mixed with return air and distributed to the room. Unlike a univent, however, this heating unit has both intake and exhaust vents on a wall shared with the hallway (Pictures 7 and 8). This unit was not operating at the time of assessment. Consideration should be given to deactivating heating elements to allow a source of air to circulate in this room during the non-heating season.

Classroom fan coil unit

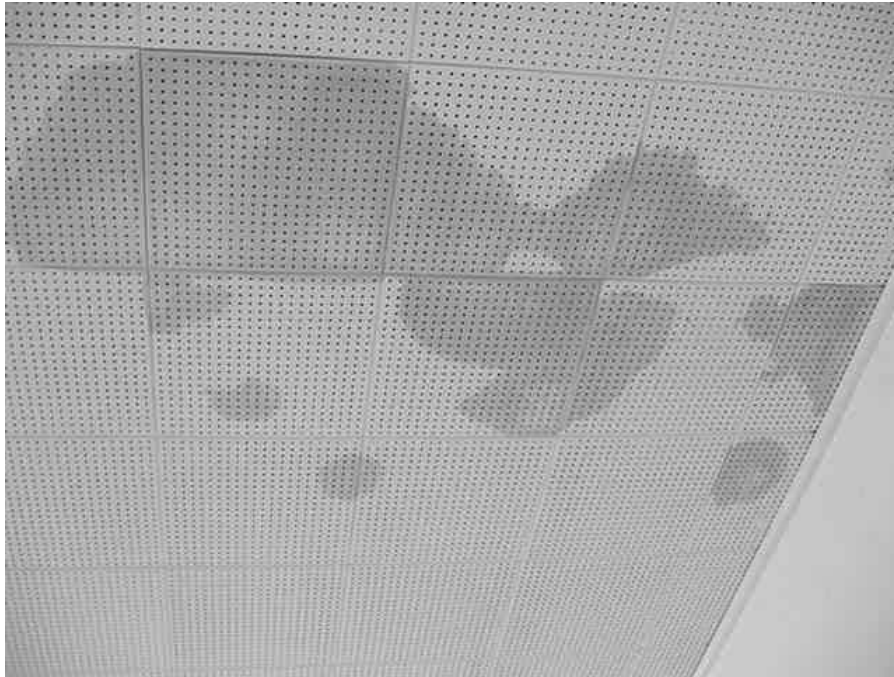
Picture 9

A few areas had water-damaged ceiling tiles (Picture 9), which can indicate leaks from the roof or plumbing system. Water-damaged ceiling tiles can provide a source for mold growth and should be replaced after a water leak is discovered and repaired. Tiles glued directly to the ceiling system are more difficult to remove. For that reason appropriate precautions should be taken when removing and replacing these tiles.

Water damage to glued ceiling tiles

8. Ensure all roof and/or plumbing leaks are repaired.
9. Replace water-stained ceiling tiles. Examine the areas above and around these tiles for mold growth. Disinfect areas of water leaks with an appropriate antimicrobial. Consider removal of glued ceiling tiles as a renovations activity. Removal of tiles directly adhered to the ceiling would be considered a renovation activity, since tile removal can release particulates and spores in particular, if the material is moldy.

Replacement of ceiling tiles may involve glues that contain VOCs. In order to minimize occupant exposure, repairs should be done while the building is unoccupied.

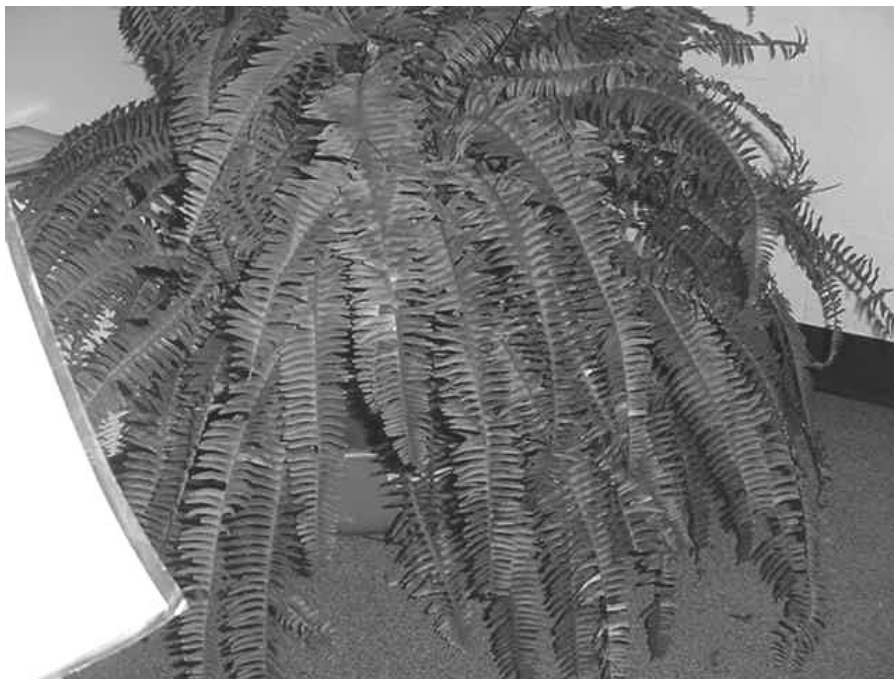
Picture 10

Plants were observed in several classrooms. In some areas, plants were observed on carpeting (Picture 10). Plants, soil and drip pans can serve as sources of mold growth, thus should be properly maintained. Over-watering of plants should be avoided and drip pans should be inspected periodically for mold growth. Plants and related materials should also be located away porous materials (e.g. carpeting, paper products) to prevent damage and potential microbial growth in/on these materials.

Plant on carpet

11. Consider installing bird screens to prevent bird roosting in the attic crawlspace.
12. Ensure plants are located away from air streams.
13. Refrain from placing plants on porous materials (i.e. carpeting).

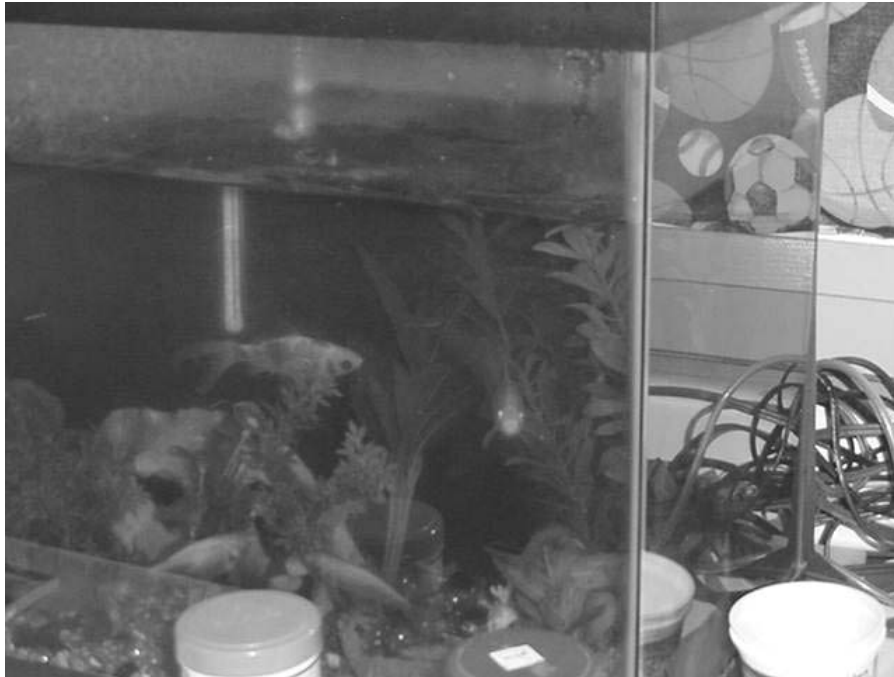
Picture 11

A number of aquariums and terrariums were seen in classrooms (Pictures 11 and 12). Aquariums should be properly maintained to prevent microbial/algae growth, which can emit unpleasant odors. Similarly, terrariums should be properly maintained to ensure soil does not become a source for mold growth.

Aquarium

14. Remove plants from the foundation wall junction around the perimeter of the building. Seal the junction with an appropriate sealer.
15. Clean and maintain aquariums and terrariums to prevent mold growth and associated odors.

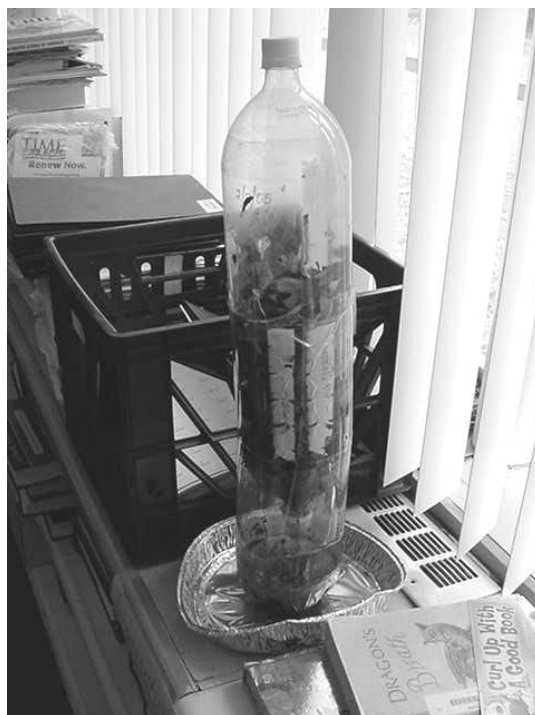
Picture 12

Terrarium

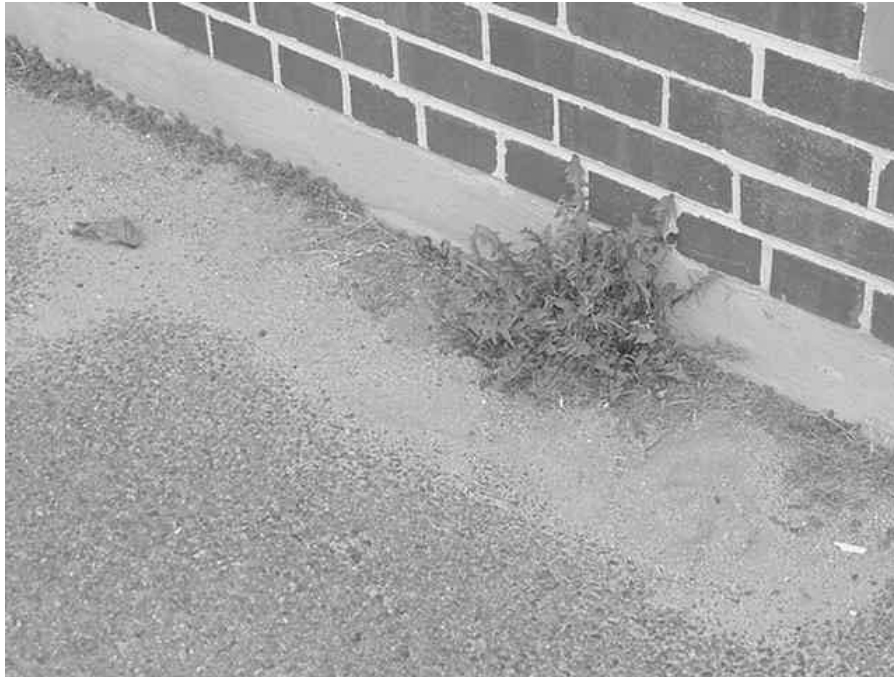
Picture 13

Plants were observed to be growing against the foundation walls (Picture 13). The growth of roots against exterior walls can bring moisture in contact with the foundation. Plant roots can eventually penetrate, leading to cracks and/or fissures in the sublevel foundation. The gutter/downspout system was damaged/missing in several areas or improperly connected to drainage pipes (Pictures 14 and 15). Excessive exposure of the exterior brickwork and foundation to water can result in structural damage. Over time, these conditions can undermine the integrity of the building envelope and provide a means of water entry into the building through capillary action through foundation concrete and masonry (Lstiburek & Brennan, 2001). In addition, a portion of the damaged downspout appears to be serving as a nesting site for birds.

Plants growing against building foundation

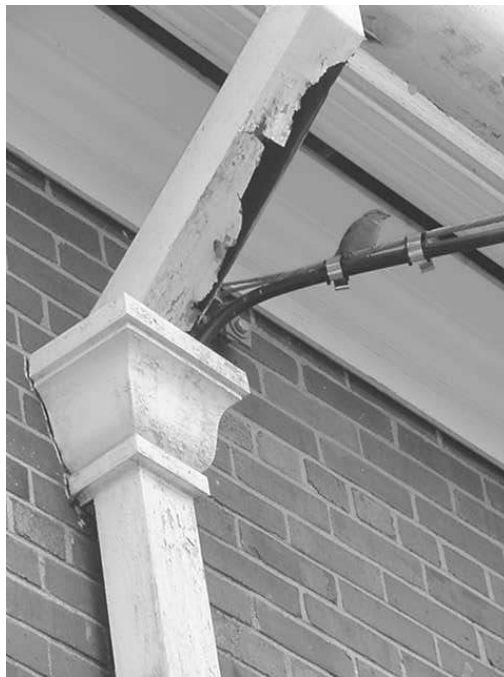
Picture 14

Damaged downspout

10. Examine all gutters and downspouts to ensure all components are intact and attached in an appropriate manner. Replace all damaged gutters and downspouts to prevent water infiltration.

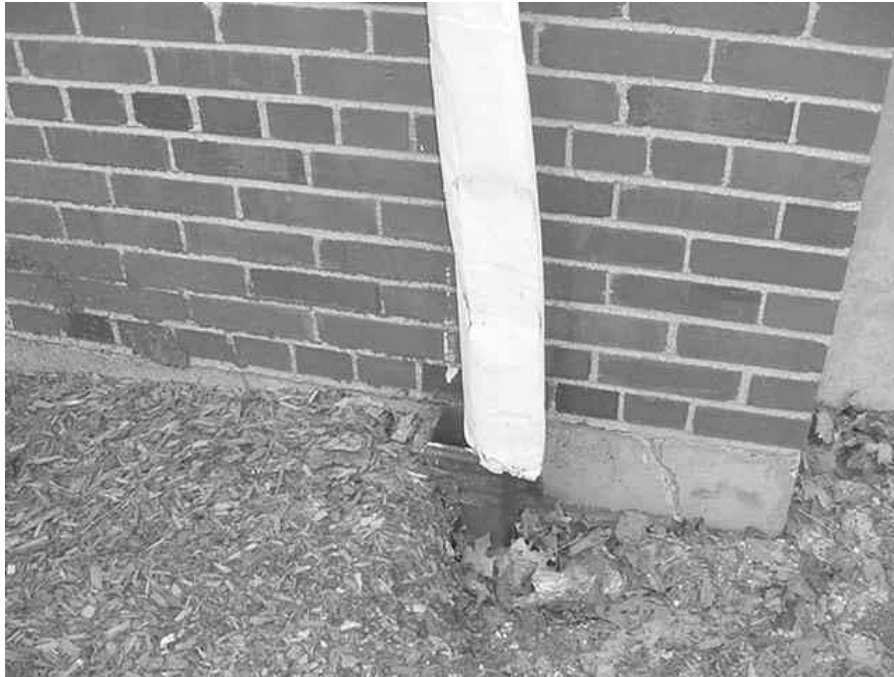
Picture 15

Downspout detached from drainage pipe

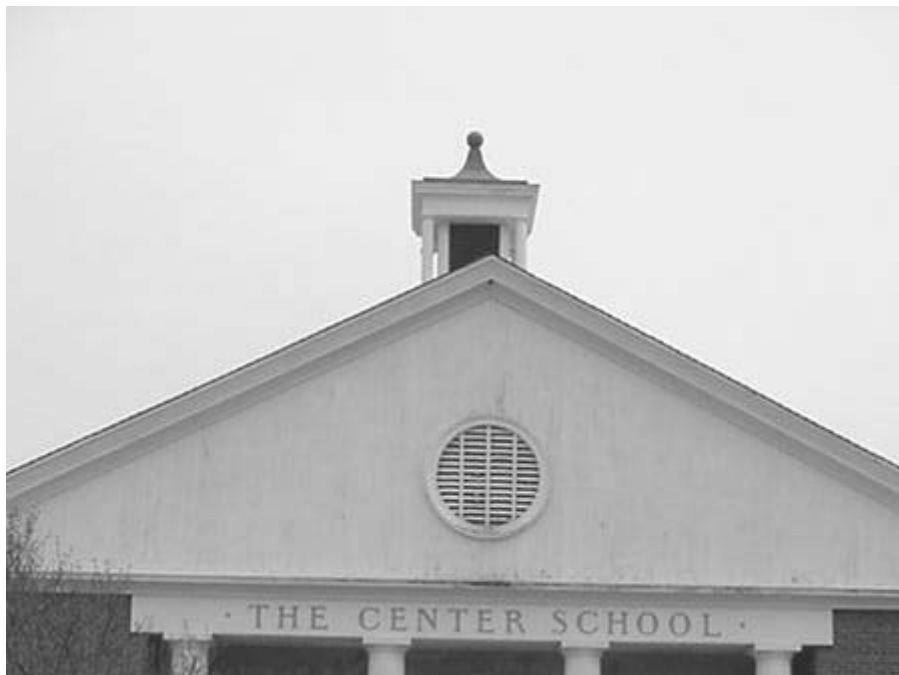
Picture 16

During the assessment, MDPH staff observed birds flying in and out of the attic crawlspace via a louver (Picture 16), indicating the potential for birds to be roosting in the attic crawlspace. Measures should be taken to prevent bird entry into the building.

Passive louver to attic crawlspace

Consideration should be given to installing bird screens/netting to prevent access. Birds can be a source of disease, and bird wastes and feathers can contain mold, which can be irritating to the respiratory system. Certain molds are associated with bird waste and are of concern for immune-compromised individuals. Other diseases of the respiratory tract may also result from chronic exposure to bird waste. Exposure to bird wastes is thought to be associated with the development of hypersensitivity pneumonitis in some individuals. Psittacosis (bird fancier's disease) is another condition closely associated with exposure to bird wastes in either the occupational or bird rearing setting. While immune-compromised individuals have an increased risk of health impacts following exposure to the materials in bird wastes, these impacts may also occur in healthy individuals exposed to these materials.

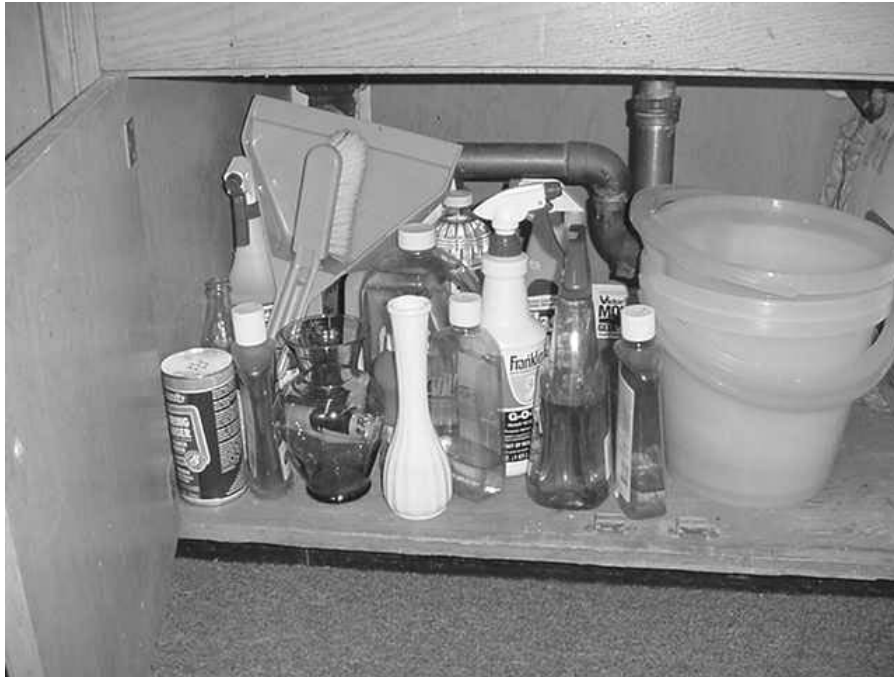
Picture 17

Cleaning products were found on countertops and in unlocked cabinets beneath sinks in some classrooms (Picture 17). Like dry erase materials, cleaning products contain VOCs and other chemicals that can be irritating to the eyes, nose and throat of sensitive individuals. Use of air deodorizers aerosolizes VOCs; thus, instead of removing the materials causing odors, the odors are masked.

Cleaners in unlocked sink cabinet

21. Store cleaning products properly and out of reach of students.
22. Clean upholstered furniture on the schedule recommended in this report. If not possible/practical, remove upholstered furniture from classrooms.

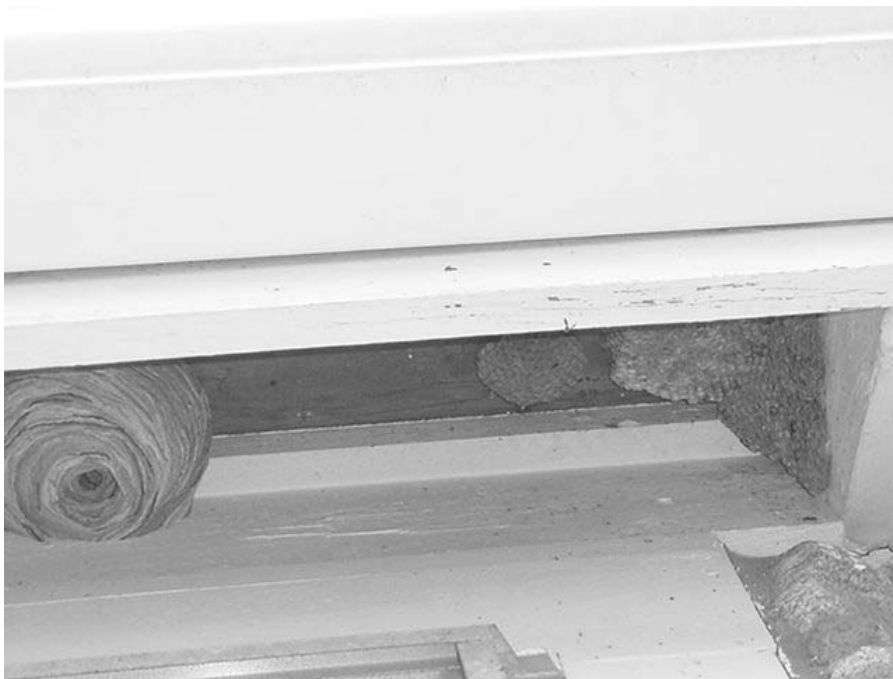
Picture 20

A number of insect nests were observed on roof eaves/exterior wall areas around the perimeter of the building (Picture 20). These nests should be removed in a manner as to not introduce pesticides and/or insects into the building. Under current Massachusetts law that, effective November 1, 2001, the principles of integrated pest management (IPM) must be used to remove pests in state buildings and grounds (Mass Act, 2000).

Insect nests

23. Remove nests in a manner consistent with the principles of IPM (Mass Act, 2000). An IPM implementation booklet is available from the Department of Agriculture: http://www.mass.gov/agr/pesticides/publications/IPM_kit_for_bldg_mgrs.pdf.
